WAR DEPARTMENT  
 U. S. ARMY AIR FORCES  
 REPORT OF AIRCRAFT ACCIDENT

45-8-4-508

56) Nature of accident Crash landing. **85**

57) Cause of accident # 3 engine ran out of oil and was feathered, # 2 engine failed to function properly.

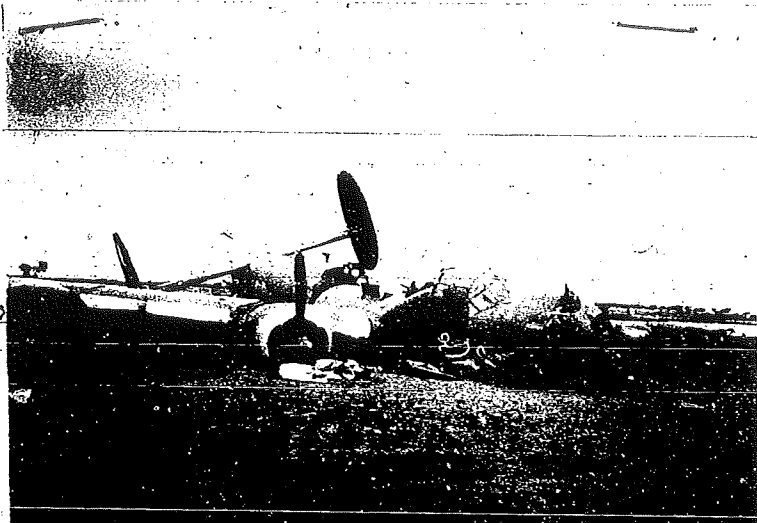
(G-222-45486) 8-4-1980 CRACKUP OF B-24H-41-28815-7395 S.

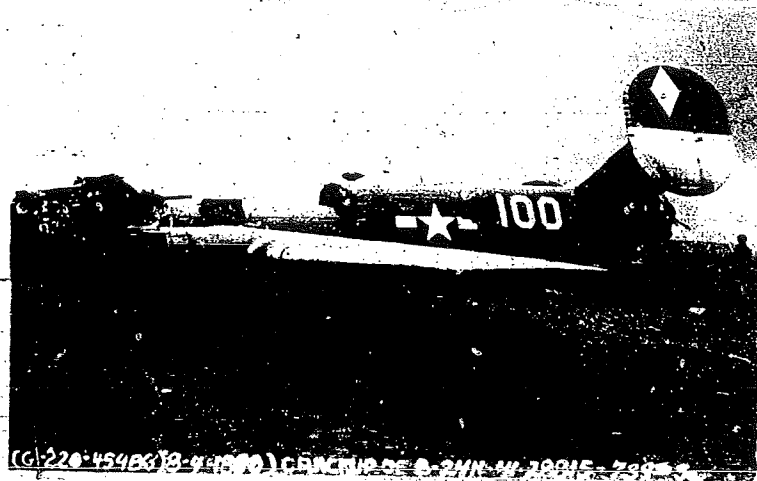
(G-222-45486) 8-4-1980 CRACKUP OF B-24H-41-28815-7395 S.
