WAR DEPARTMENT  
U. S. ARMY AIR FORCES  
REPORT OF AIRCRAFT ACCIDENT

(1) Place San Giovanni Airfield, Italy (2) Date 26 December 1944 (3) Time 1020  
AIRCRAFT: (4) Type and model B-24H (5) A. F. No. 42-50416 (6) Station APC 520  
Organization: (7) 15th Air Force (8) 454th Bomb Gp. (9) 738th Bomb Squadron (H)  
(Command and Air Force) (Group) (Squadron)

(56) Nature of accident: Taxing accident. IC

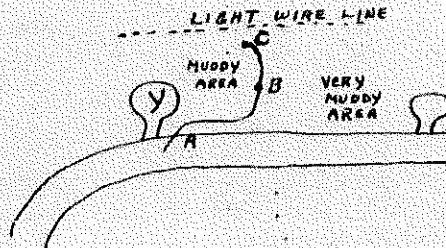
Upon returning to home field following a landing at another airdrome due to weather, pilot taxied to original parking area which was adjacent to hardstand Y. This area has been used for approximately six months in all kinds of weather, and was currently quite muddy.

Pilot left taxi-way at point A, taxied parallel to runway upon direction of ground crew chief and turned away from taxi-way, heading toward light line. At point B ground crew chief motioned aircraft to make left turn and park facing hardstand Y. Aircraft continued toward light line, the left wheel sliding for approximately twenty (20) feet then taking hold, the aircraft turning to the left with the right wing striking a light line pole, breaking the pole and damaging the wing.

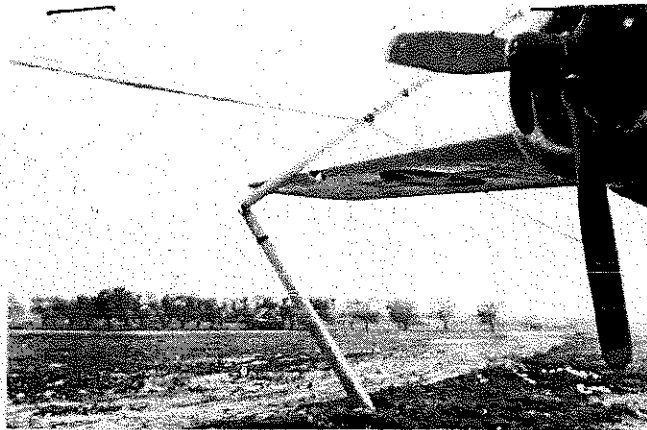
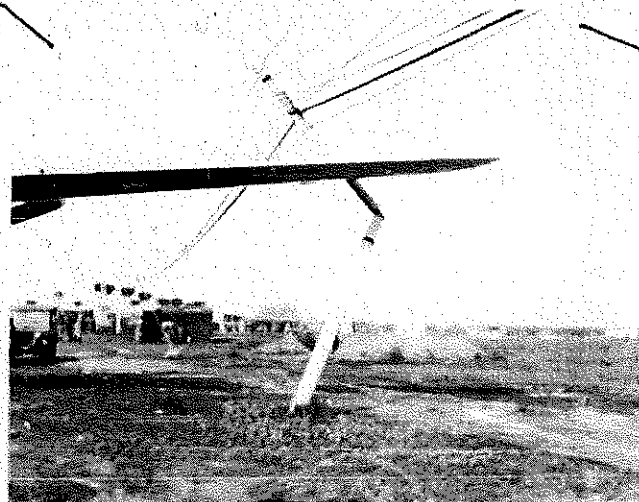
The accident to 416 happened on hardstand 11A as we attempted to park on our hardstand. The right wing of the plane was damaged.

4. While the plane was skidding, a member of the crew appeared above the flight deck through the escape hatch. I motioned with my hands and arms to hold the plane in a position facing North. The crew member who was above the flight deck then disappeared. Suddenly the plane made a left turn and crashed into a pole damaging the right wing.
