Accident No. 14-3-27-542

WAR DEPARTMENT  
U. S. ARMY AIR FORCES  
REPORT OF AIRCRAFT ACCIDENT

(1) Place APC 520, U. S. ARMY (2) Date 27 March 1944 (3) Time 1725  
 AIRCRAFT: (4) Type and model B-24H (5) A. F. No. 42-52245 (6) Station APC 520  
 Organization: (7) 15th AF (8) 454th Bomb Gp (9) 739th Bomb Sq (H)  
(Command and Air Force) (Group) (Squadron)

(56) Nature of accident Undershot runway on approach for landing. Right landing gear gave away due to rough ground.

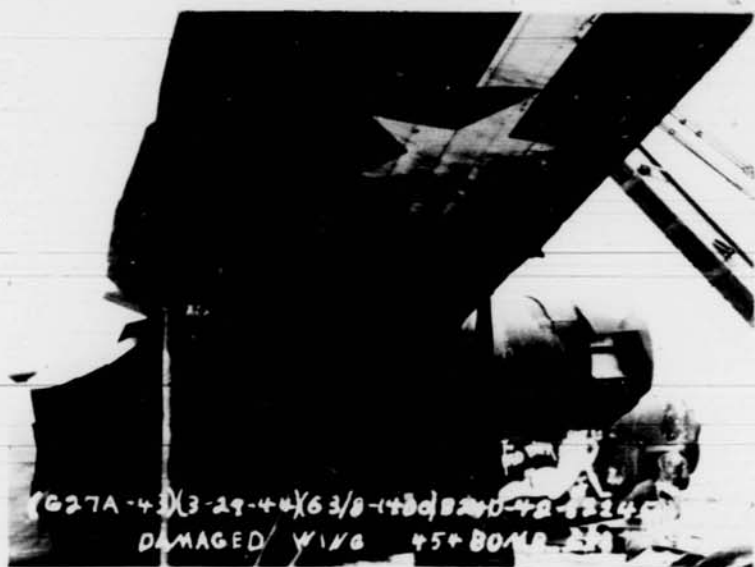
DAMAGE	(49) LIST OF DAMAGED PARTS
(46) Aircraft <u>M 4</u>	Right landing gear broken off. Right wing damaged. Ball turret torn out. Bomb bay section buckled severely.
(47) Engine(s) <u>1 1 1 1</u>	
(48) Propeller(s) <u>1 1 1 1</u>

(57) Cause of accident Strong gusty wind caused pilot to undershoot runway; hit the lip of the runway and landing gear broke off.

(G 27A-43)(3-29-44)(63/0-1400) B24D-42-52245  
DAMAGED WING 45+ BOMB GP

In the future, transition will only be flown under more favorable operating conditions, and instructor personnel will be more alert in taking over when the condition necessitates.
